Case Study // Intumescent Coatings

Office Parking Refurbishment

Kings Court, Leatherhead

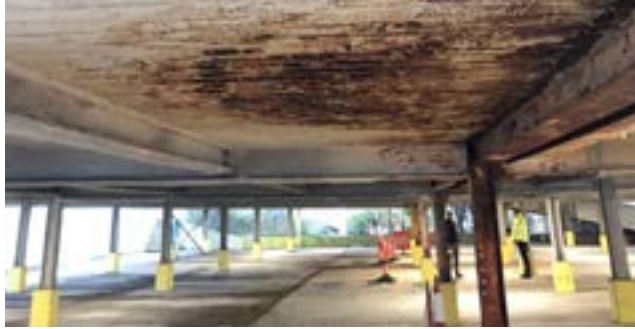
Before: Steel Soffits, Columns & Beams Badly Corroded

The steelwork was previously protected by a vermiculite-type material, many of the areas of which had delaminated resulting in loss of fire protection properties and serious surface corrosion of many steel members. All steelwork therefore had to be grit-blasted back to bright metal

The primary scope of this refurbishment was to transform the existing steelwork and reinstate 60-minute fire protection.

(SA2.5) to remove the existing coatings and corrosion product.

All columns, soffits and structural steelwork were then protected with a new 3-component intumescent coating which swells in the event of a fire to protect the steelwork underneath. This particular car park required a 60-minute fire rating to allow for a safe evacuation in the event of a fire.

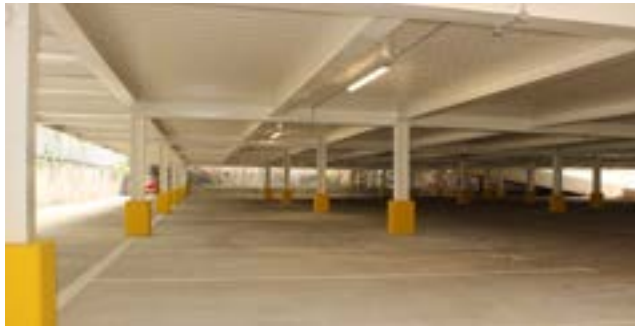
After: Structure Repaired

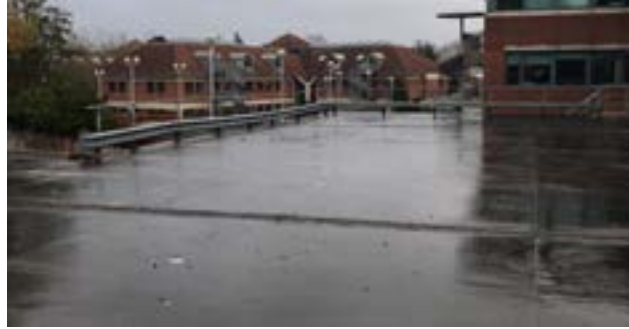
Before: Split & Damaged Asphalt & Drainage

To avoid steel corrosion from reoccurring, the car parking deck above needed to be watertight. The existing asphalt waterproofing system on the car park had failed and was re-waterproofed with Sika's RB58 fully reinforced car park decking system. This would ensure no more water ingress into the car park underneath.

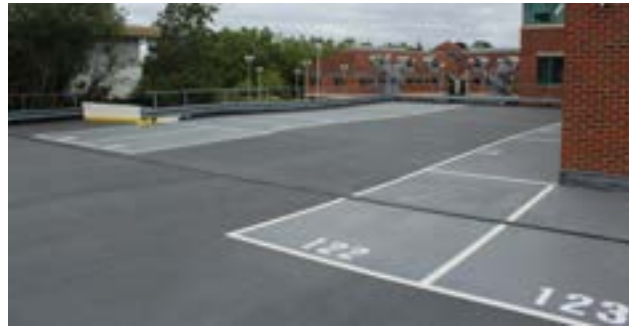
After: Fully Watertight Parking Deck

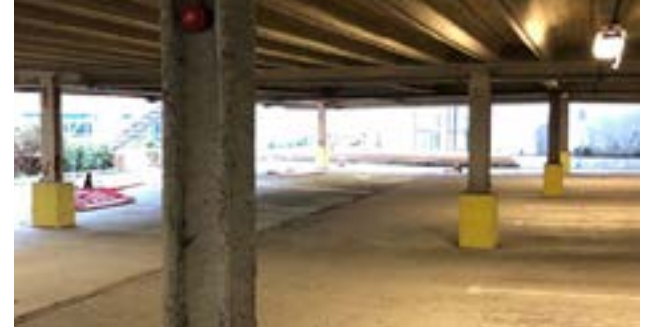
Before: Intumescent Coatings Failed

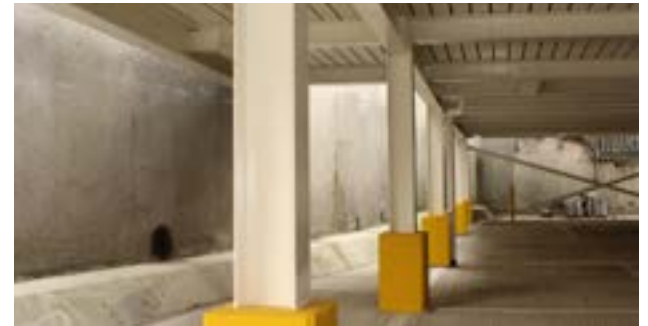
After: New Intumescent Coatings Applied
