Office Car Park
Binding Site, Birmingham

SCOPE

Case Study // Office Parking

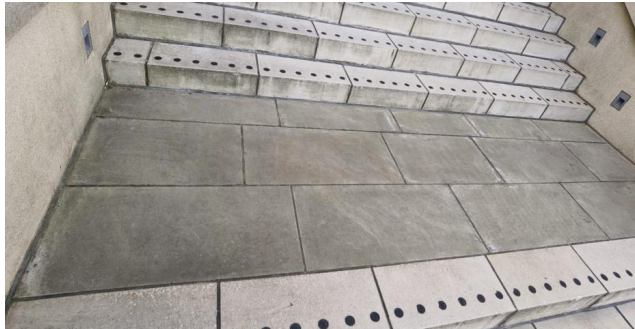
Before: Leaking Entrance Steps

With water ingressing to the undercroft car park via the

existing entrance steps, these were removed and replaced with new stone treads installed following the application of the Sikalastic waterproofing system. Re-waterproofing works adjacent to the exit ramp were also required to make watertight.

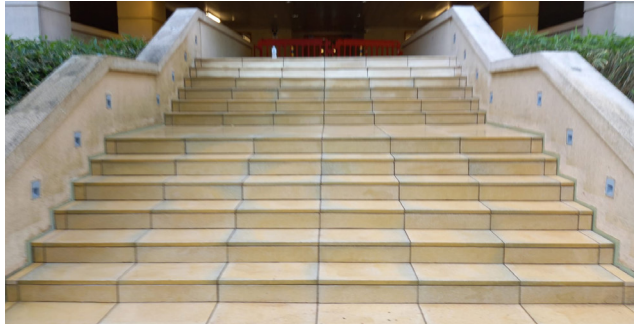
After: Steps Fully Waterproofed

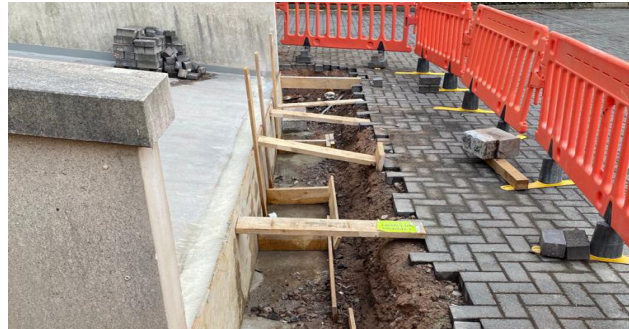
The block paving and sub-base around the perimeter of the building had to be removed followed by excavation to expose the existing concrete surfaces of the capping

During: Block Paving Removal & Excavation

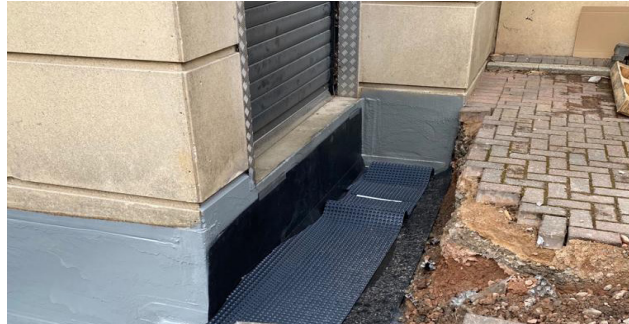
During: Drainage Installed

beams. Following the installation of new ACO drainage channels to the entrance and exit ramps, Sikalastic 8800 was hot-spray applied to re-waterproof the excavated areas. After back-filling, the original pavers were reinstated with the addition of new yellow paving creating a pedestrian walkway.

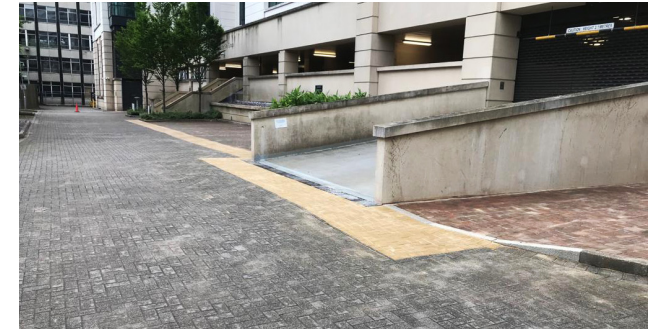
After: New Pedestrian Walkway

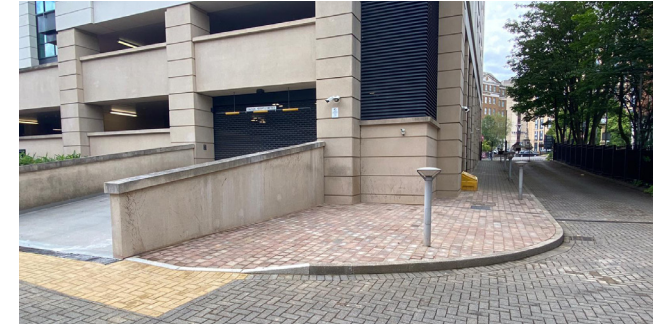
After: Exit Ramp Watertight
