## Case Study // Car Parks

## Client | Bell Building Projects Role | Specialist Sub-Contractor

The scope of this project was to waterproof the external concrete slab - where water was penetrating from several areas into the basement of this multistorey office building.

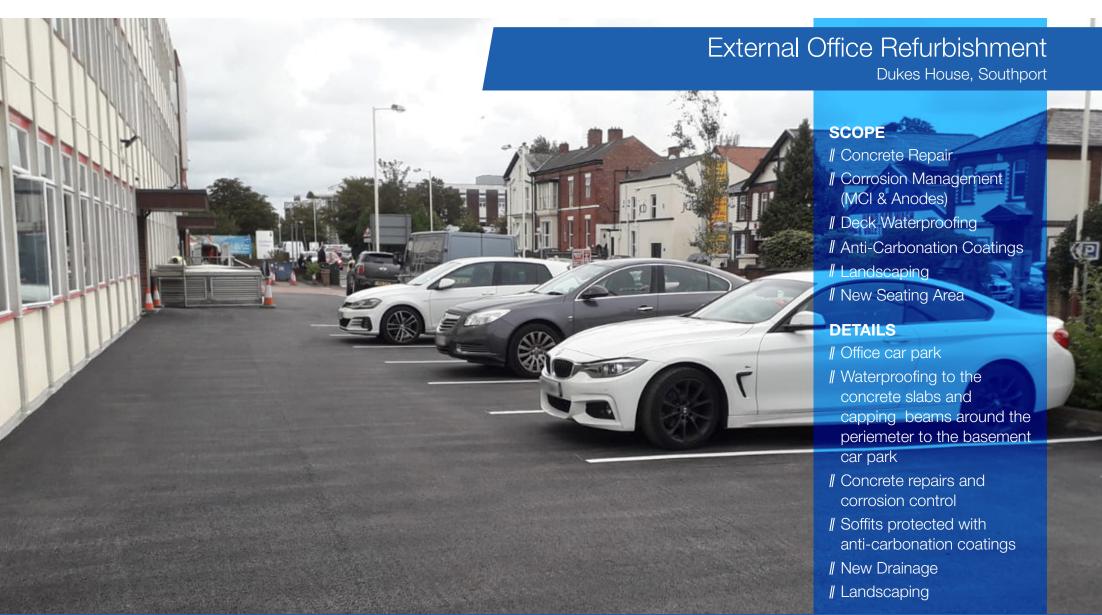
**During:** Waterproofing Detail To Basement Structure

To expose the concrete slab, the tarmacadam and sub-base had to be excavated along with the seating area slabs. The slab showed various defects which were

repaired before the application of **Sikalastic 8800 podium deck system.** Hot melt pellets were broadcast into the system and a new tarmacadam surfacing was overlayed forming a strong adhesion. The car park layout was redesigned to improve it's capacity and usability. Ducting and cables were embedded into the new surface to offer the option to add electric car charging ports at a later date.
