Residential Parking & Sports Pitch

Beaufort Court, Fulham

Case Study // Podium Waterproofing

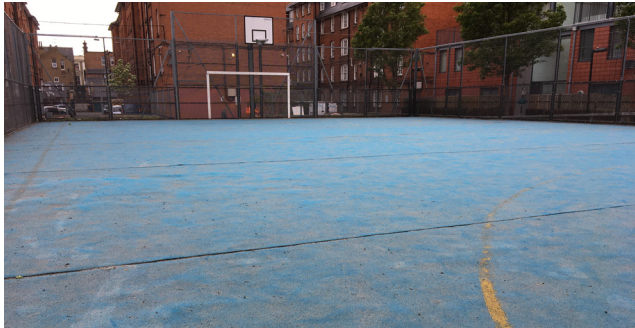
Before: Dark & Unwelcoming Environment

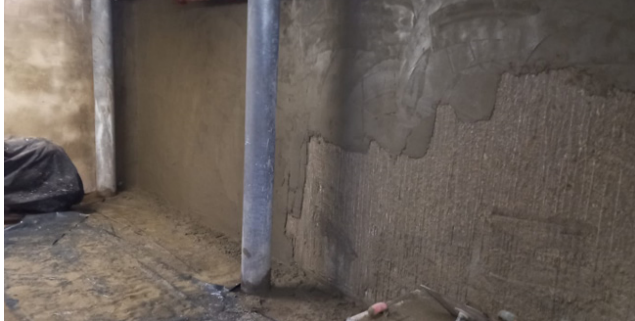
During: Cementitious Render To The Basement Car Park

was cleaned and fully encapsulated and waterproofed using Sika 1, a cementitious render to extend the life of the structure for many years to come.

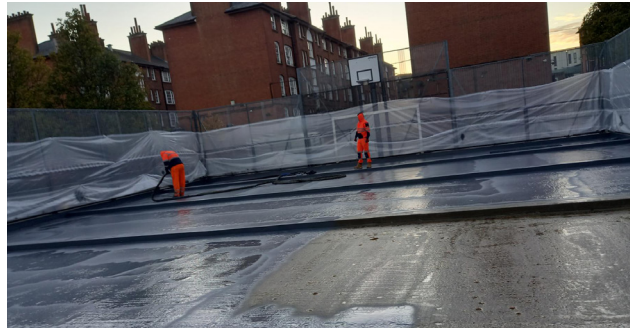
During: Application of Spray Applied Waterproofing

The podium deck had historic water ingress resulting in damaged vehicles due to the sports surface being at the end of its serviceable life. The existing Lytag screed was excavated down to the structural slab before being waterproofed with Sika's spray applied Sikalastic 8800 and Combiflex joints. A new screed was installed to reinstate levels which was also waterproofed to ensure

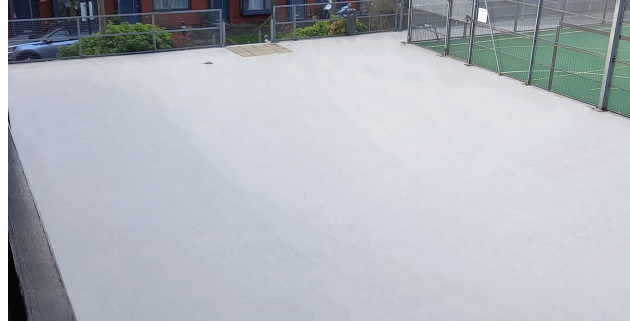
After: Fully Protected Courtyard & Walkways

The surrounding walkways and courtyard – totalling some 400m² were upgraded using Sika's fully reinforced RB58 anti-slip system with bespoke quartz sand for aesthetic. Our client wanted to enhance their structure's aesthetics by adding green roofs near the entrance of the car park.

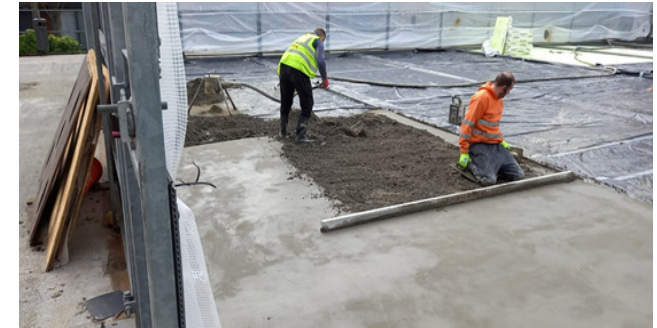
During: Screeding Reinstatement

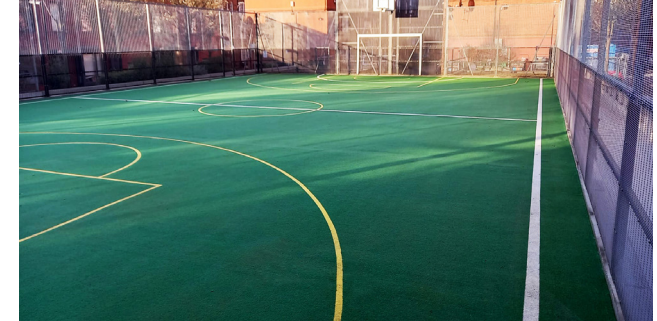
After: Light, Bright & Watertight Sports Surface

there would be no more water penetration. A new 'all-weather' sports surface – including Sports Shock Pad and Sports Needle-punch Carpet - was installed with various linemarking for the community to use.
