Heritage Restoration

Bottle Alley, Hastings

Case Study //

Repair & Protection

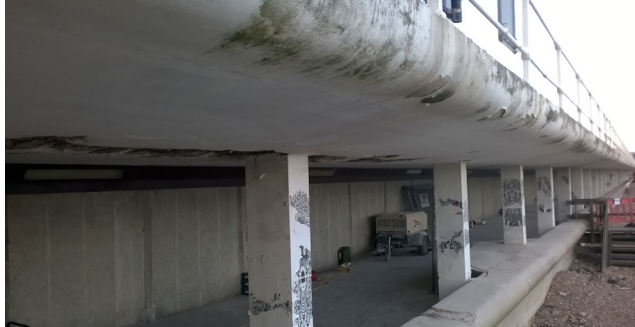
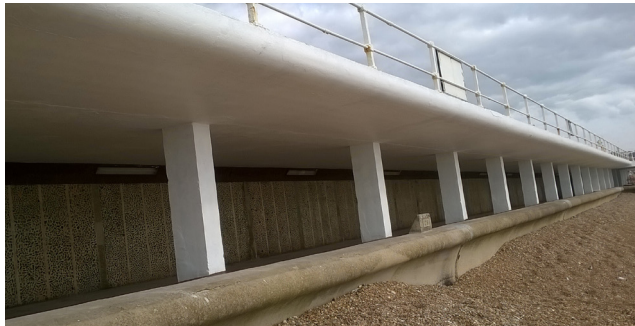
Before: Significant Long-Term Damage

After: Now Fully Protected In The Marine Environment

The scope of this refurbishment was to carry out extensive concrete repairs at Bottle Alley, Hastings, designed and built in the 1930's by the then Hastings borough engineer Stuart Little. It is named after the countless multi-coloured pieces of glass bottles embedded into the concrete retaining wall.

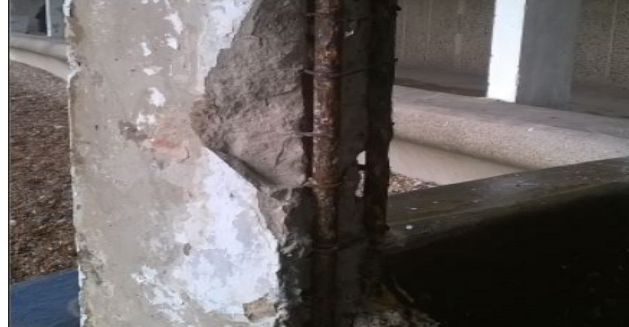
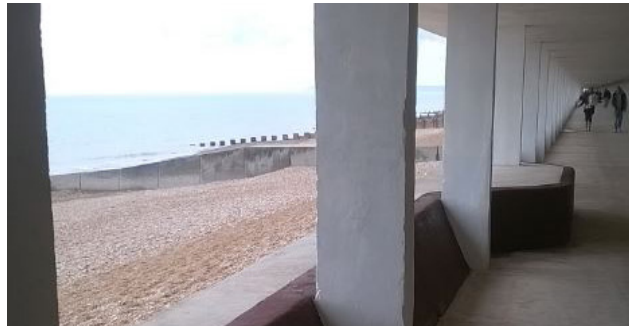
Before: Extensive Concrete Defects

After: Extensive Repairs Carried Out

After a full hammer survey, some 785 defects were found along the 480-meter lower deck walkway requiring repair, using more than 6m³ of Remmer's Betofix repair mortar. Remmer's protective concrete coatings were subsequently applied to the 3,345m² of columns and soffits to provide

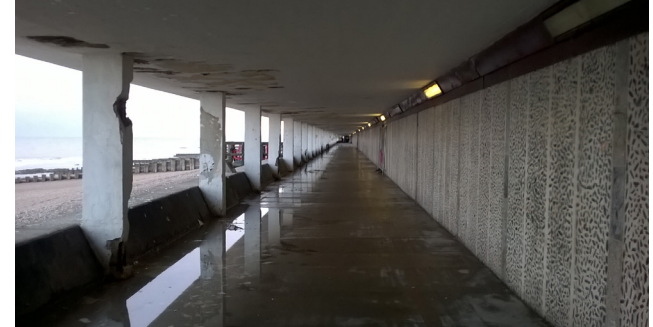
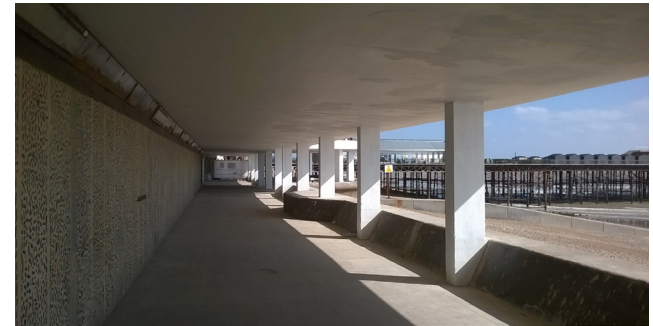
Before: Columns and Soffits Unprotected

After: Protective Coatings Applied

long-term protection to the structure. The project was completed and handed back to the client within the allocated time frame of 12 weeks and within budget.
