Shopping Centre Roof

The Victoria Shopping Centre, Southend-On-Sea

Case Study // Roofing

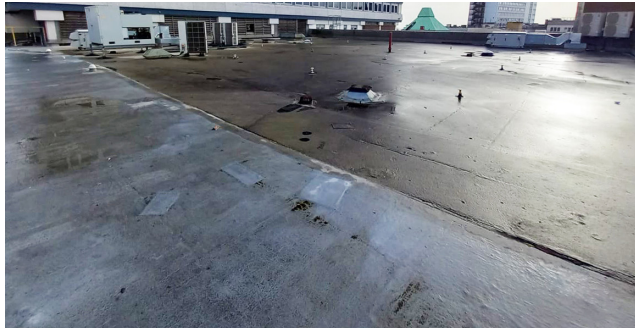
Before: Existing Waterproofing System Damaged

Across the four roofs the waterproofing was damaged to the point it was allowing water ingress into the centre below. The existing waterproofing was comprised of a variety of systems including asphalt, single ply, felt and liquid applied coatings. Upon closer inspection of gym walkway roof it was found that the existing single

ply waterproofing system had failed, allowing water to penetrate beneath it and causing the insulation to become saturated.

The original scope of works intended for the gym walkway roof to be repaired with an overcoat of the existing single ply covering, but due to the extent of the damage a full new waterproofing system had to be installed. To ensure the area could be thermally upgraded the roof was stripped back to the structural substrate before the new insulation and vapour control layer could be installed. The roofs were

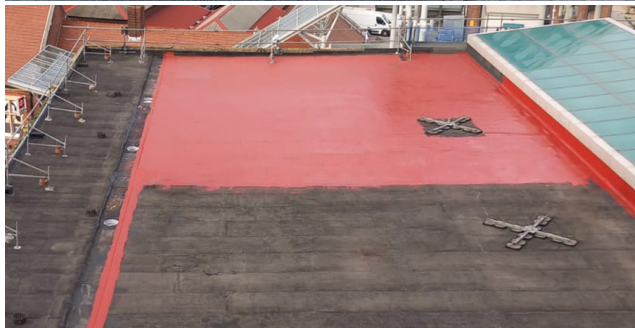
During: Application of Sika Decothane Waterproofing System

all cleaned to remove any vegetation and contaminants prior to the application of new materials. Following localised repairs all roof areas were fully re-waterproofed using the Sika Decothane waterproofing system.

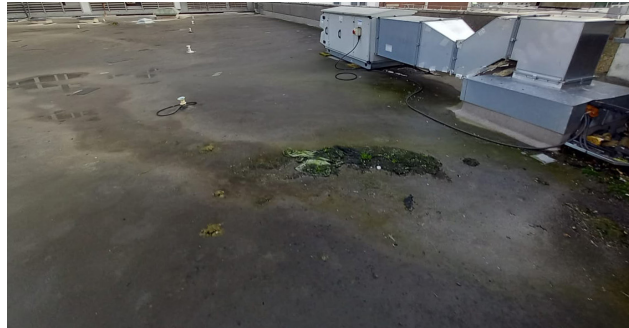
Before: Vegetation Growth to Several Roof Decks

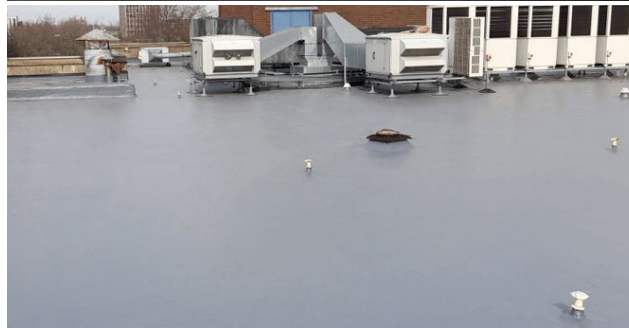
After: Fully Re-Waterproofed Roof Area

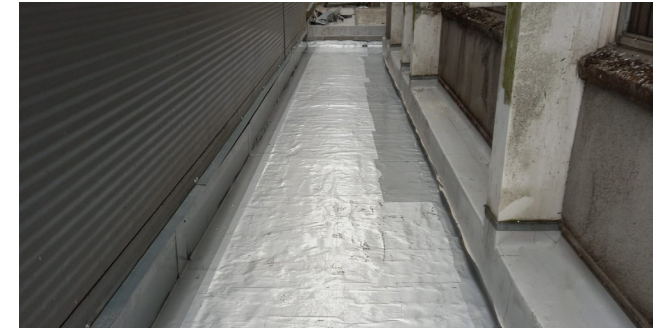
During: Insulation and VCL Installed on Gym Walkway

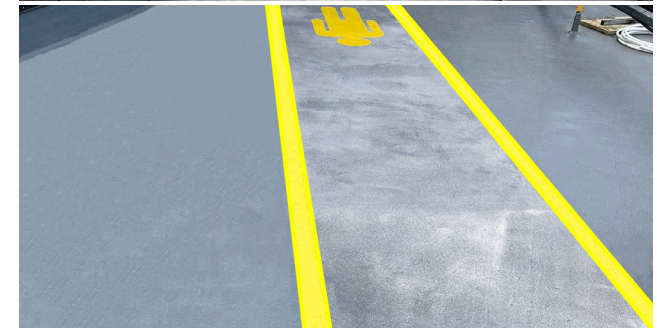
After: Vibrant New Line Markings on Gym Walkway
