Facade Refurbishment

London Road, Redhill

Case Study // Repair & Protect //

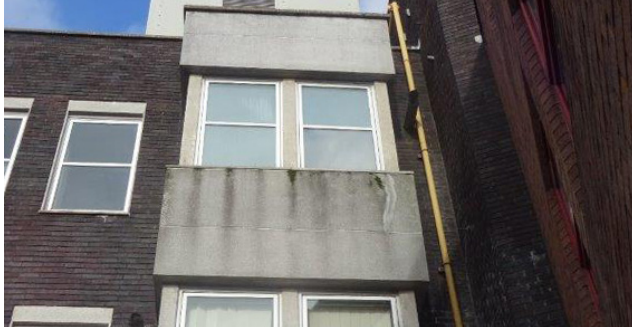
Before: Cracked Facade

Following a condition survey, it was noted that the concrete coping stones were loose due to crumbling mortar bedding with the parapet walls showing signs of structural movement. The corner of the building's brickwork were in poor condition and the mortar joints were badly damaged due to long-term weathering. The terraced bay windows were showing issues with ponding water and vegetation

To counter the structural movement, seven new movement joints were created and installed to the external and internal face of the wall, measuring roughly 1.7LM each, strengthening the walls and allowing the eleven bay windows to be safely waterproofed. All of the coping stones were removed for the installation of PVC cavity closers and a 300mm wide polythene damp proof course embedded into the fresh mortar before the stones could be reinstated or replaced with like for like.

The window facades and lintels were cleaned and repaired while crack stitch repairs were completed to secure the brickwork in place. The corner of the building which was in poor condition required the removal and replacement of some 140 rustic blue bricks due to spalling.

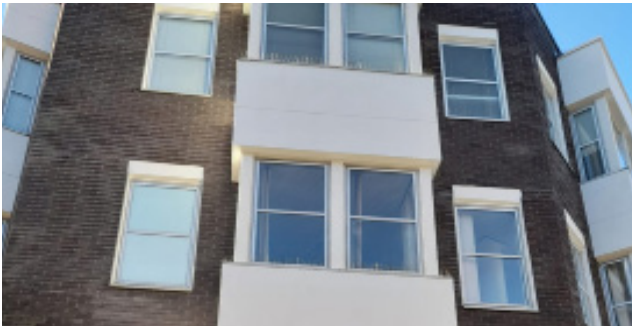
After: Repaired & Renewed Facade

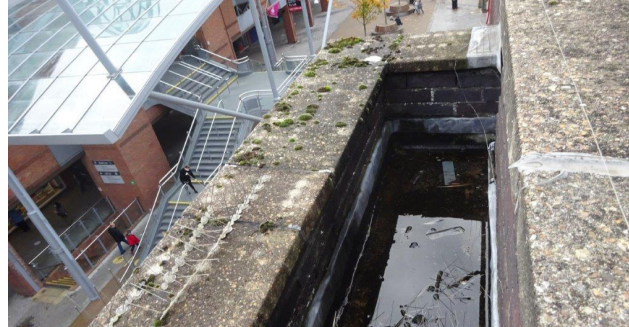
Before: Ponding Water

growing, allowing a potential water ingress issue.

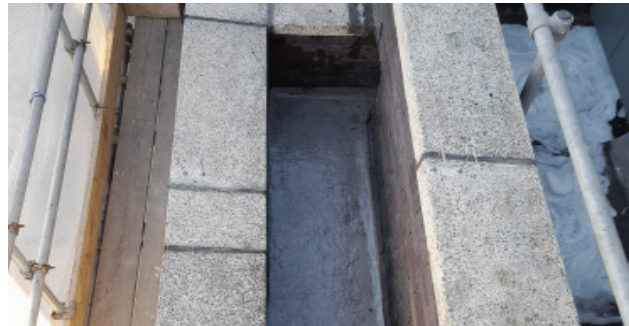
After: Watertight Terrace Bays

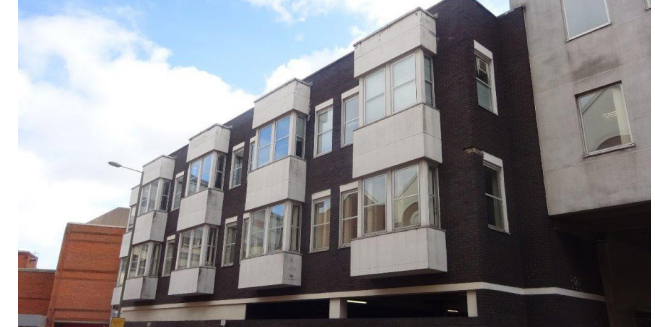
Before: Aged Facade

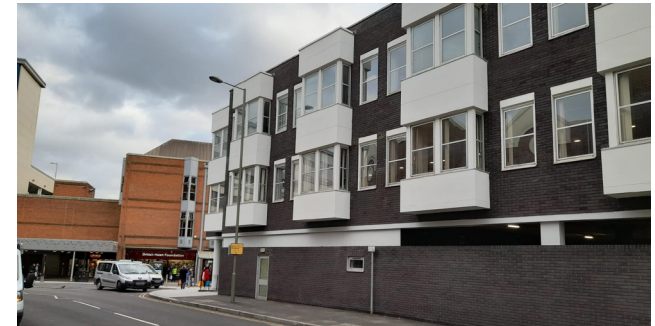
After: Light & Bright Facade Improvements
