## State-of-the-art Facility Roof

Pharmaceutical Building, Wokingham

# Case Study // Roofing

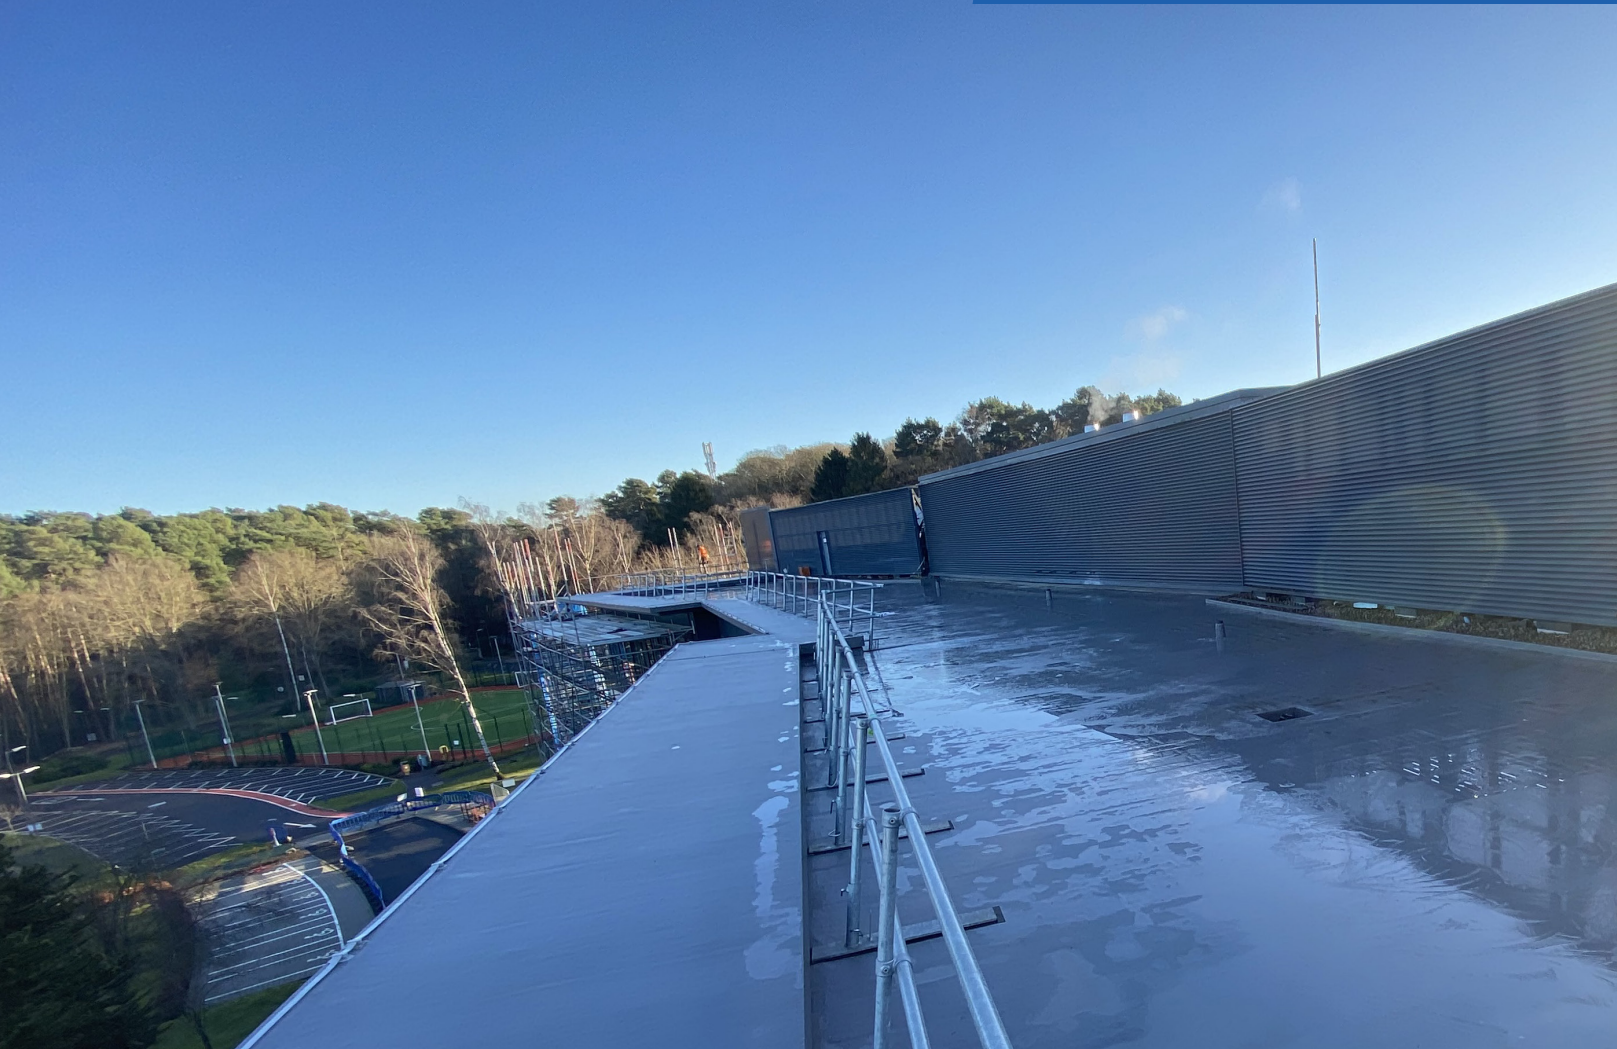
- // State-of-the-art facility roof  
deck
- // Installation of insulation at  
120mm thickness
- // Two roof decks comprising  
of 600m<sup>2</sup> re-waterproofed  
with low odour Centaur  
APA system

**The scope of this refurbishment was to replace the existing insulation and waterproofing system on the roof of this state-of-the-art facility which had issues with historic leaks.**

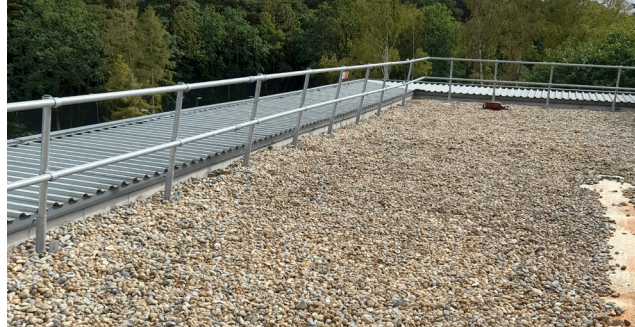
**Before:** Pebble Ballast & Cracked Asphalt

Pinpointing the cause of the water ingress was difficult due to the inverted roof being covered in pebble ballast and plant units. These pebble ballast stones were bagged via hand and hoisted to the skips below with the existing insulation being removed from site as well.

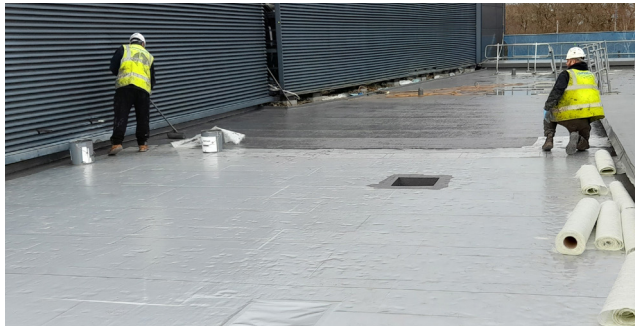
**During:** Application of Low Odour Waterproofing System

the live working environment. The chosen Centaur APA Waterproofing system has proven to be low odour whilst offering better thermal values and easier to maintain for the client.

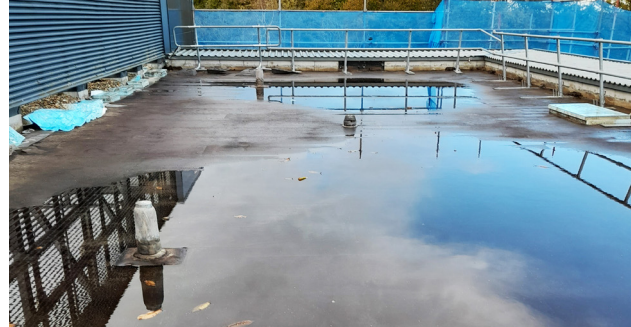
**Before:** Ponding Issues

Following on from the removal of the pebble ballast and insulation, an inspection could be conducted to the asphalt substrate which showed numerous cracks allowing water to penetrate the building. Asphalt repairs were completed the new insulation and vapour control layer could be installed to the roof deck.

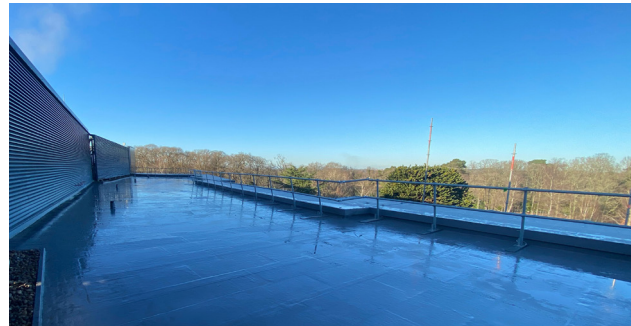
**After:** Light & Bright Exterior Improvements

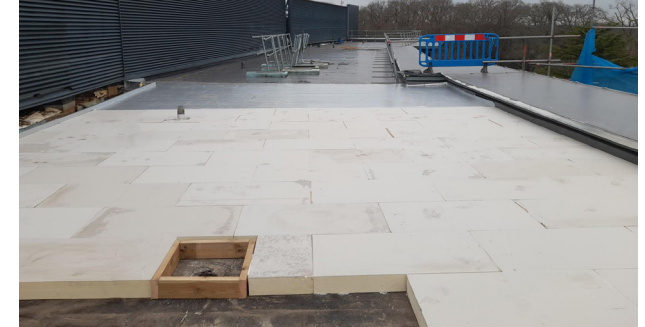
**During:** 120mm Thick Insulation and VCL

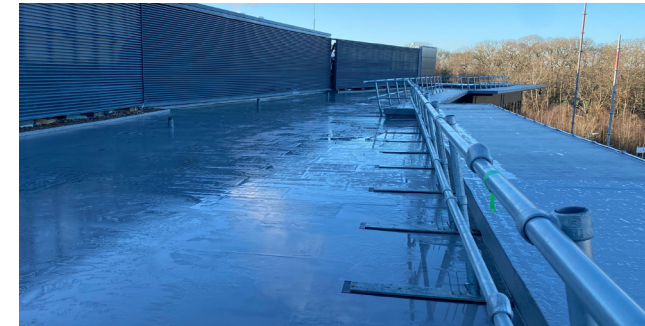
**After:** Fully Watertight With No Ponding Issues

The two re-waterproofed roof decks were completed in phases within 10 weeks with minimal disruption to the occupants.
