Town Centre MSCP Refurbishment

Culver Street MSCP, Salisbury

Case Study // Car Parks

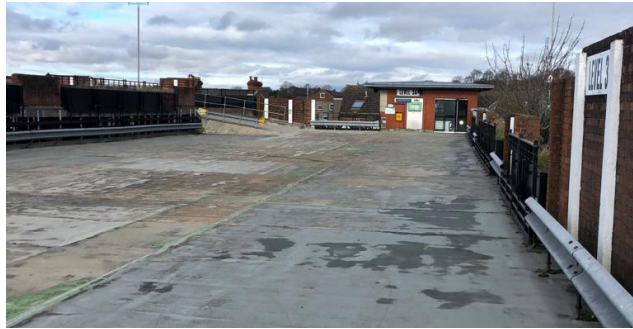
Before: Existing Failed Waterproofing System

The scope of this refurbishment was to repair and re-waterproof the top deck and entrance/exit ramps of the split-level MSCP, carrying out concrete repairs and renewing the deck coatings which had come to the end of their serviceable life allowing water ingress into the levels below.

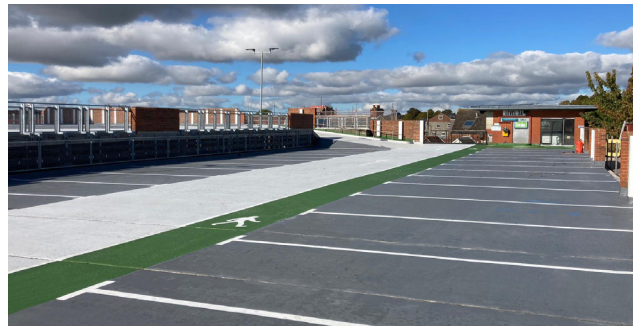
After: Fully Protected Decks With Mesh Panel Infills

Following on from these works, the top decks and entrance/exit ramps were prepared by planing and captive shot blasting to remove the existing deck coatings and any contaminants. Sika's partially reinforced RB28 deck waterproofing system was applied to the 2,500m² top deck in contrasting colours of light/dark grey and green

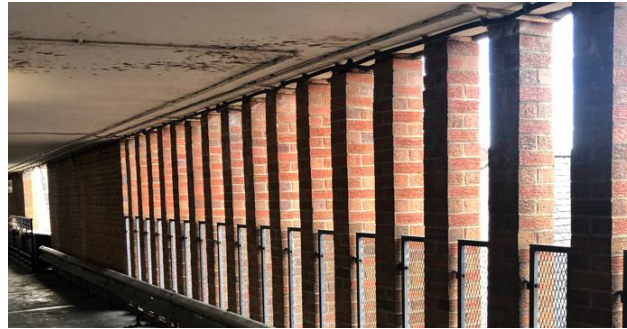
Before: Decks & Columns Unprotected

The planters, which surrounded parts of the top deck, were removed due to the maintenance coats and were no longer aesthetically pleasing for the users of this car park. Once the newly exposed concrete could be examined, concrete repairs were conducted as well as to the concrete fingers

which showed signs of spalling. Anti-carbonation coatings were applied to the concrete fingers to protect them in the future. New edge protection and mesh panel infills were installed for pedestrians safety, while new crash barriers were fixed on the lower levels 2 and 3.

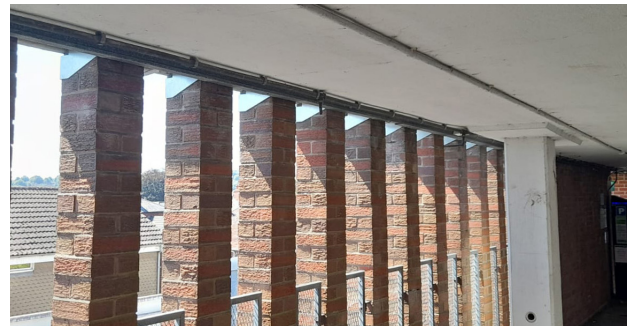
After: Light & Bright Interior Improvements

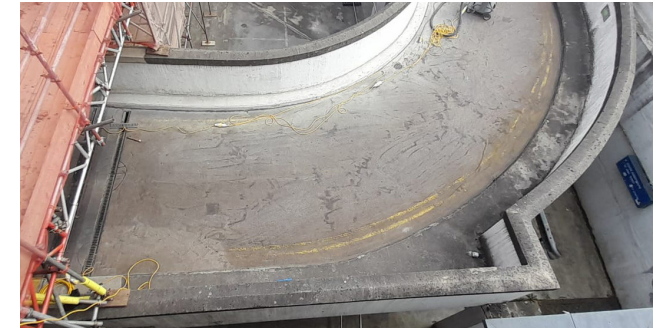
Before: Failed Mechanical Movement Joint

which created walkways for the pedestrians to use. Throughout all levels of this MSCP, there was a requirement for the removal and reinstatement of polysulphide movement joints using Sika Pro-3 totalling some 700LM. The entrance and exit ramps were waterproofed using Sika's fully reinforced RB58 decking system following the replacement of a mechanical expansion joint.

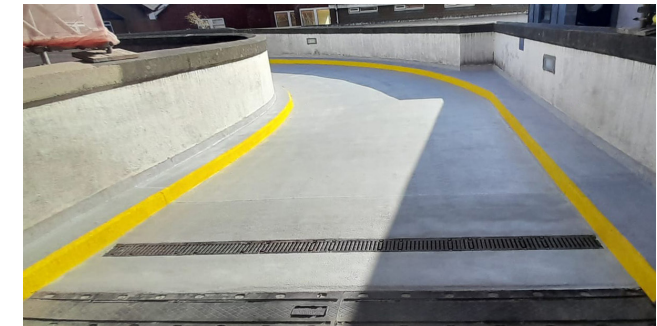
After: Replacement Expansion Joint
