## Shopping Centre MSCP Refurbishment

Thamesgate Shopping Centre, Gravesend

# Case Study // Car Parks //

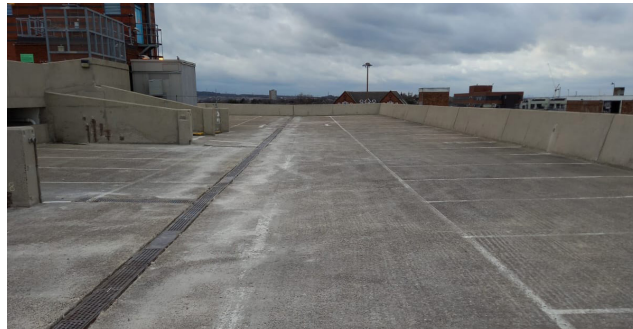
**Before:** Dark & Unwelcoming Environment

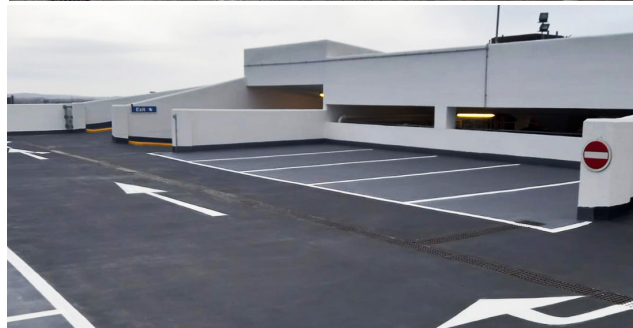
**After:** Light & Bright Exterior Improvements

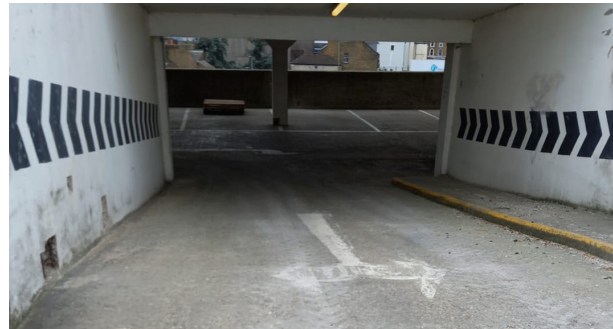
**The scope of this refurbishment was to repair and waterproof the uncoated top deck and exposed annexes of the lower levels which were suffering from considerable spalling concrete.**

**Before:** Decks & Columns Unprotected

Extensive concrete repairs were carried out throughout the entire 6-story car park to the soffits, columns, parapets and decking; a variety of techniques were used including resin injection. Once all repairs were completed, 11,000m<sup>2</sup> of anti-carbonation coatings were applied to help protect the newly repaired concrete in the future.

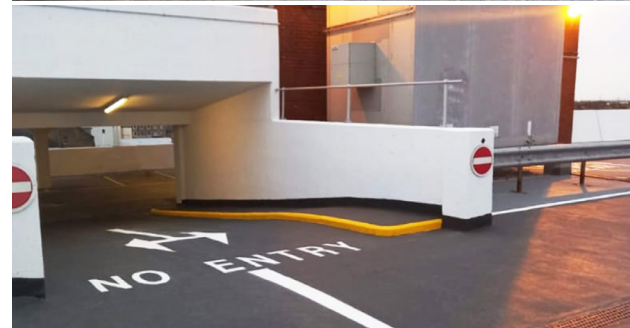
**After:** Fully Protected Decks & Columns

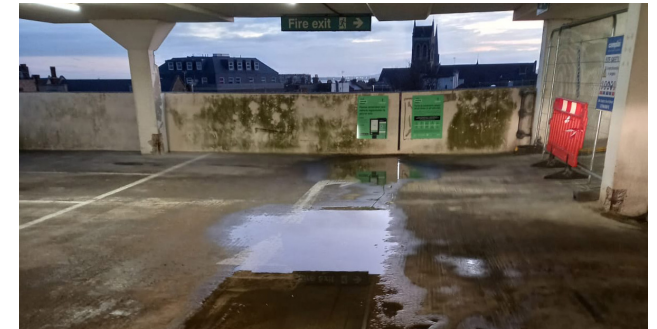
The internal decks were suffering from ponding issues around the perimeters where driving rain was entering the car park over the parapet walls due to prevailing winds coming from the River Thames. New drainage channels were created to maintain the water run-off and cease the ponding water issues. Selected drainage down pipes had historic leaks and required a waterproof lining to be applied to ensure they were impermeable.

**Before:** Ponding Water Due To Prevailing Winds

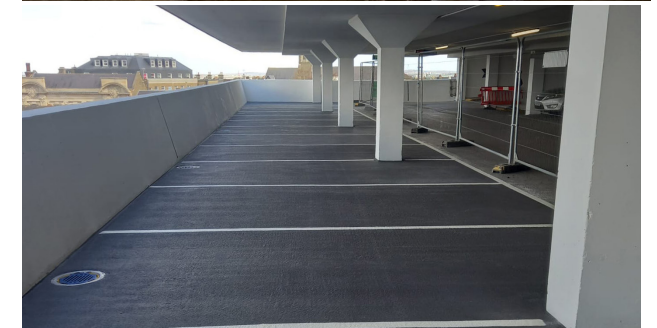
**After:** Perimeters Waterproofed With New Drainage Channels

of the lower levels were prepared to remove any contaminants or imperfections and were levelled off, before using Sika's partially reinforced RB28 deck waterproofing system – which has crack-bridging, traffickable and slip-resistant properties – was applied to ensure that the areas were made watertight.
