## Residential Parking

Abbey Sands Car Park, Torquay

# Case Study // Car Parks

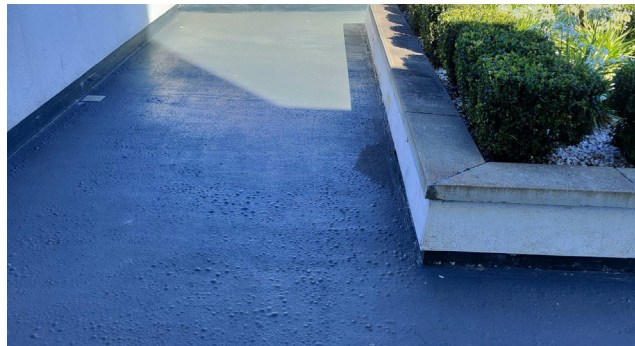
**Before:** Blisters Caused By Outgassing

The existing waterproof coatings had failed due to a primer issue while the proximity of the cliff edge allowed water ingress into the screed causing outgassing and subsequent failure of the system. The podium deck had a strict 2-tonne weight limit requiring careful consideration of the coating removal equipment.

A Terminator Stripper with a 1-tonne weight was utilised, ensuring compliance with weight restrictions whilst effectively removing the coatings. This approach enabled the process to be completed in-house, minimising the projects costs and time.

Following the coating removal, screed repairs became necessary due to the water ingress, which caused the topping of the screed to deteriorate. To address the water ingress issue, Flowcrete's PMMA Deckshield Rapide, a

high performance system known for its durability and reliability, was applied to the 800m<sup>2</sup> top deck providing a robust waterproofing layer.

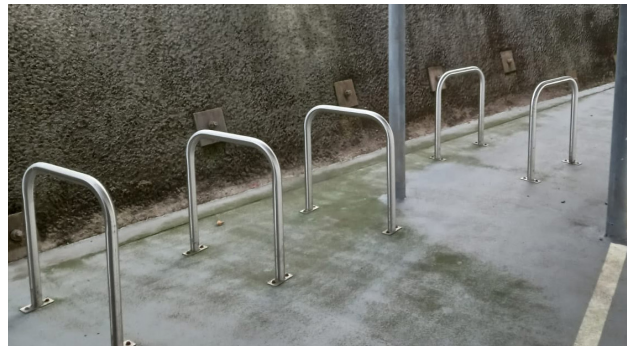
**Before:** Cliff Edge & Car Park Connected

Additionally, a comprehensive solution was devised to prevent further water ingress. A cliff edge detail was incorporated effectively breaking the connection between the cliff edge and the car park. A bund was installed to mitigate water infiltration, therefore safeguarding the integrity of the podium deck against future deterioration.

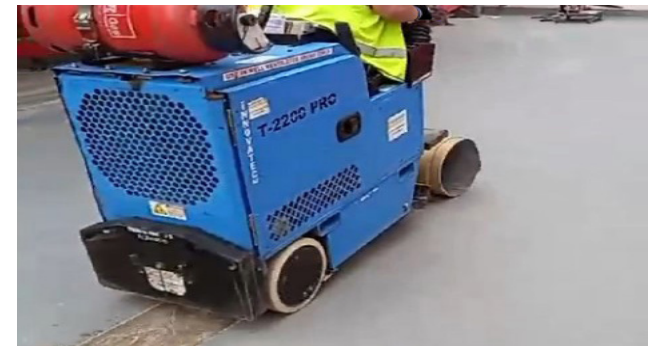
**During:** Coating Removal With Weight Restrictions

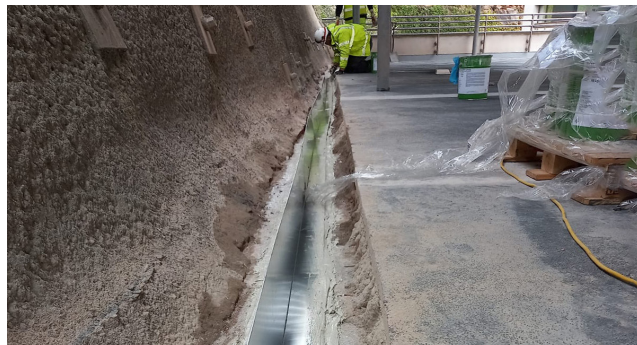
**During:** Cliff Edge Detail

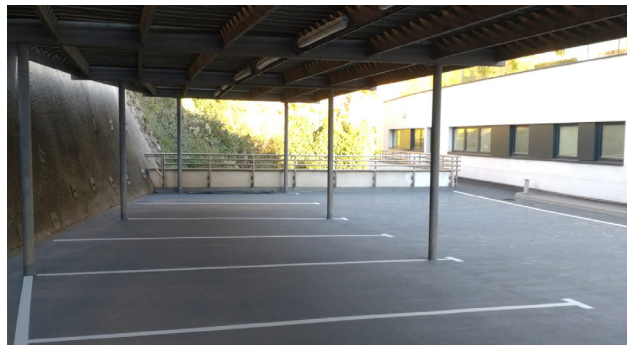
**After:** Light & Bright Exterior Improvements

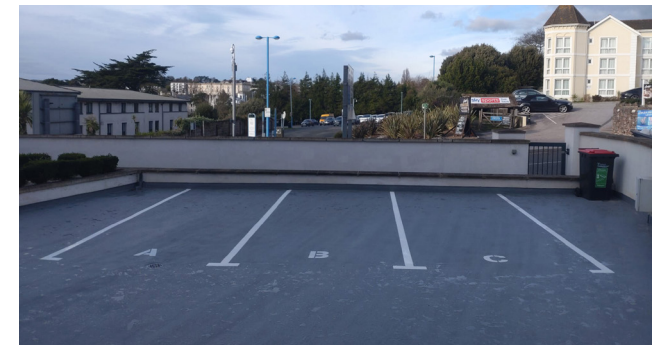
**After:** Fully Repaired & Protected Decks
