Shopping Centre MSCP's Refurbishment

The Plaza Shopping Centre, Wokingham

Case Study // Car Parks

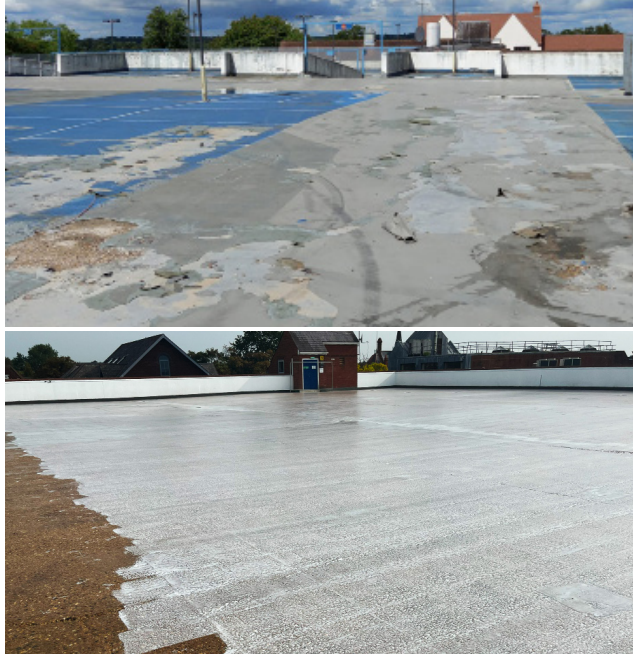
Before: Delaminated Deck Coatings

During: Pre-Primer To Combat Outgassing

The existing waterproofing system was failing due to being

in a very poor condition. Delamination was occurring across the whole car park, primarily focused to the drive aisles. This system was removed using a specialist 'ride on' planer with works commencing on the top deck then progressing down through the car park, level by level.

Trials were undertaken using Westwood's primer to validate the bond to the existing and repaired concrete substrate. Whilst the bond strength was good, these trials identified

substantial outgassing of the concrete, likely caused by the ingress of moisture into the concrete through the existing failed coating.

Westwood's 821 pre-primer was applied, sealing the concrete slab and stopping the outgassing phenomenon at the source of the problem, thus eliminating the risk of pin holes through the decking system. Westwood's Wecryl fully crack bridging waterproofing system was then applied to the 3,330m² top deck.

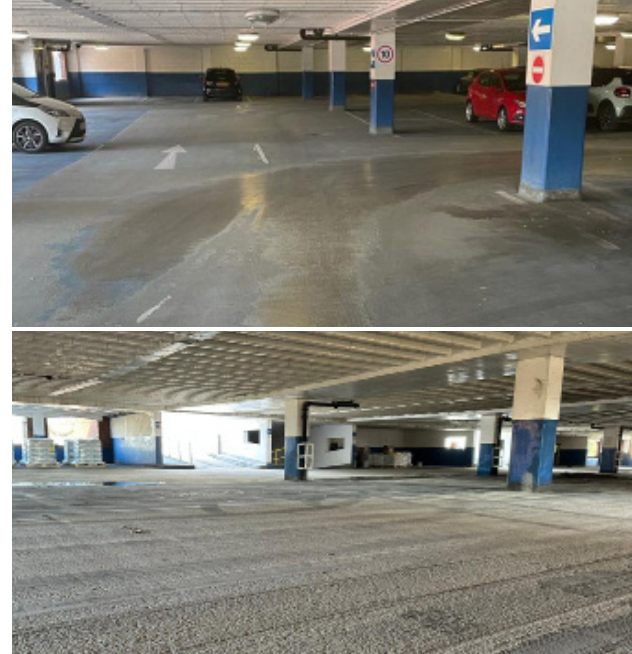
Before: Dark & Unwelcoming Environment

During: Concrete Repairs Completed and Decks Prepared

Significant repairs were required to the concrete substrate on the top deck. There were also concrete defects to the internal decks, soffits, columns and walls throughout the structure, leading to in excess of 25 tonnes of defective concrete being broken out. Before concrete repairs could be completed, sacrificial anodes were installed to the reinforcement to alleviate the ongoing corrosion.

The waterproofing of the top deck allowed for the levels below to be enhanced. Concrete repairs and resin injection crack repairs were completed to the concrete surfaces throughout the car park, previously unachievable due to water ingress. Followed by anti-carbonation coatings, protecting the structure from the underside whilst the

These new protective, yet decorative coatings, combined with a new lighting system on the roof and interdecks now offers patrons a bright and safe environment in which to park.

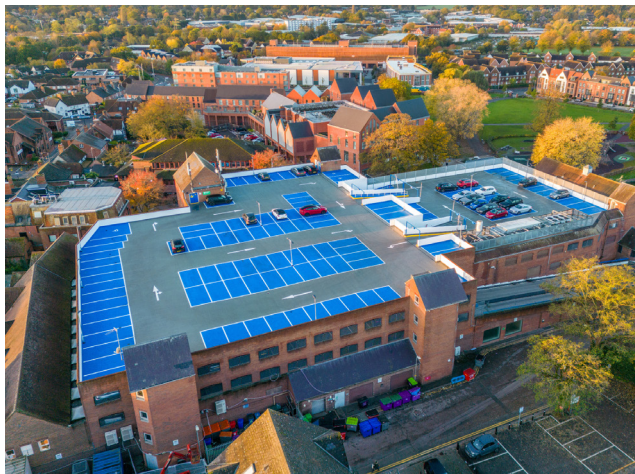
After: Aesthetically Enhanced Top Deck

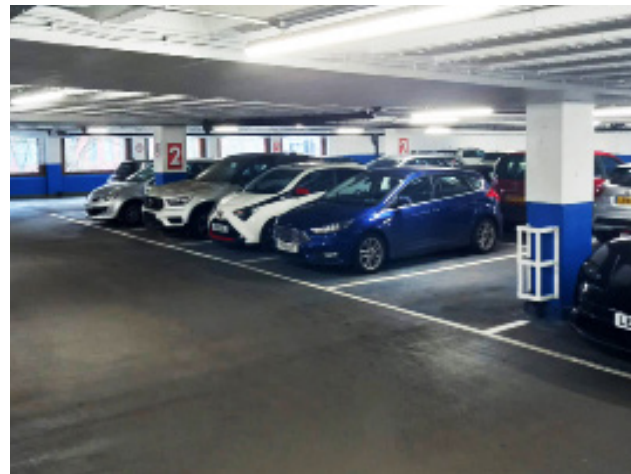
After: Light & Bright Interior Improvements

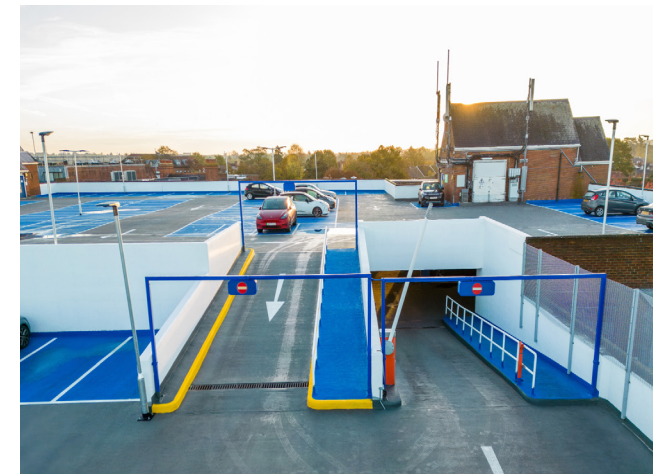
After: Fully Protected Decks & Ramps

bottom of the ramp, a buried waterproofing system was installed then finished with a tarmac wearing layer. Cemplas kept the car park operational throughout these works by introducing a Highways approved traffic management system from the main road into the multi-storey car park, creating a safe and efficient one way system so vehicles could enter on one side of the ramp.
